PANTHER

VS

T-34

Ukraine 1943

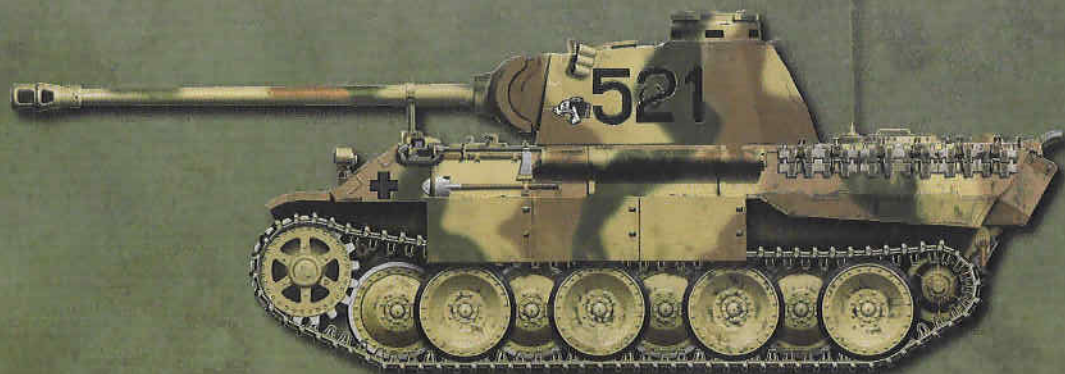
PANTHER SIDE-VIEW

8.66m

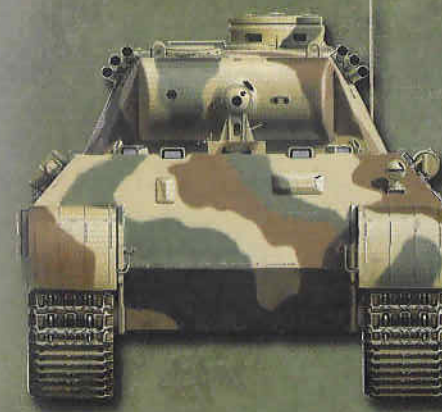
PANTHER FRONT-VIEW

3.42m

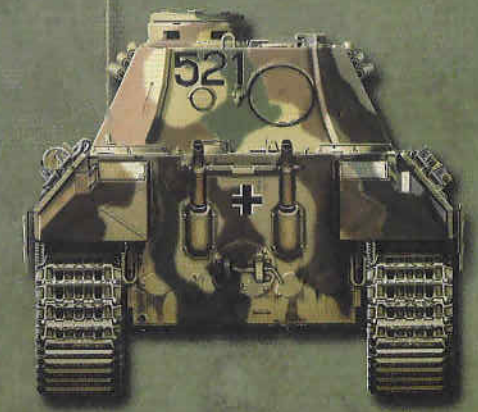
PANTHER REAR-VIEW

2.95m

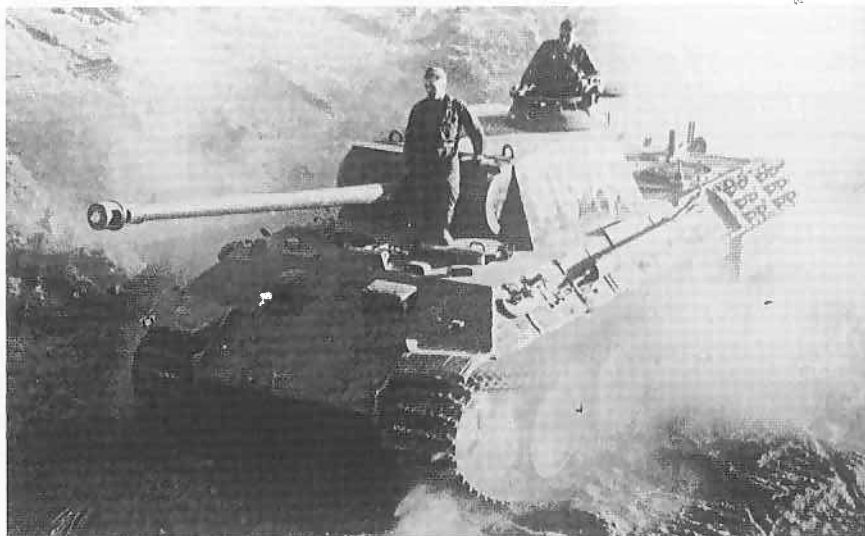
A captured Panther Ausf. G in Soviet service near Warsaw in September 1944. Many intact Panthers were abandoned during the retreats of 1943–44 and used in special platoons. Although Soviet tankers liked the Panther's optics and gunnery, they were unable to keep the tanks running for very long. (Tank Museum, Bovington)

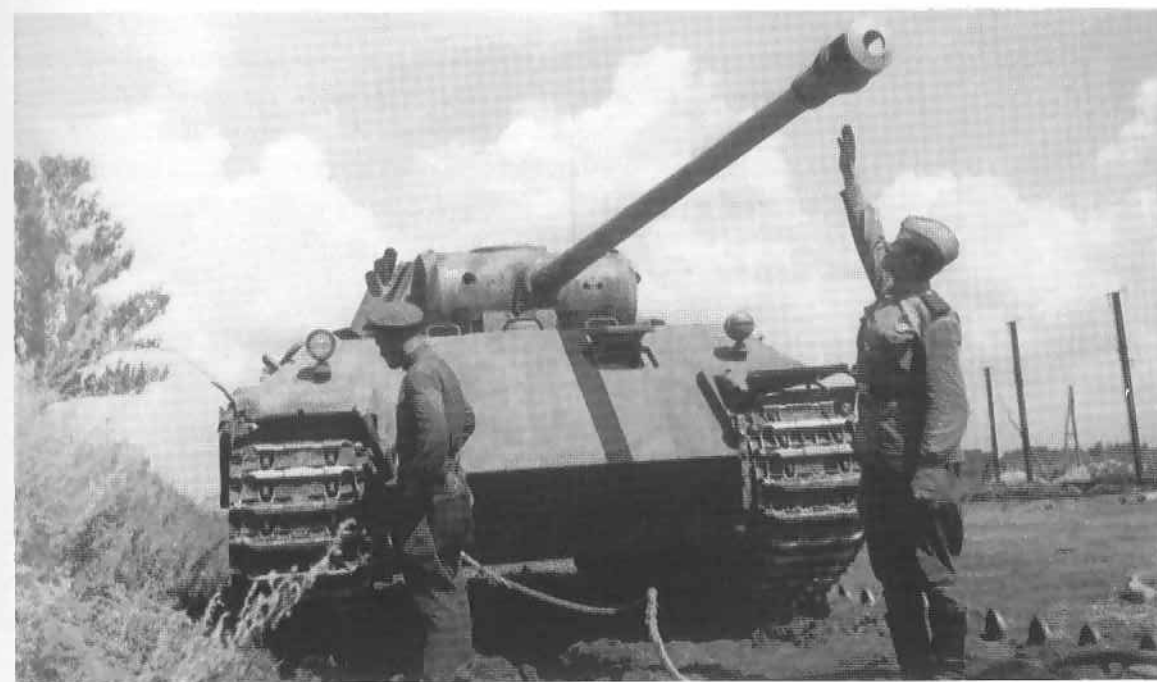
Panther 824 from the 52nd Panzer Battalion, which was captured by the Soviets. Note the multiple 45mm AT hits on the gun mantlet, which damaged the TFZ sights. (Courtesy of the Central Museum of the Armed Forces Moscow)

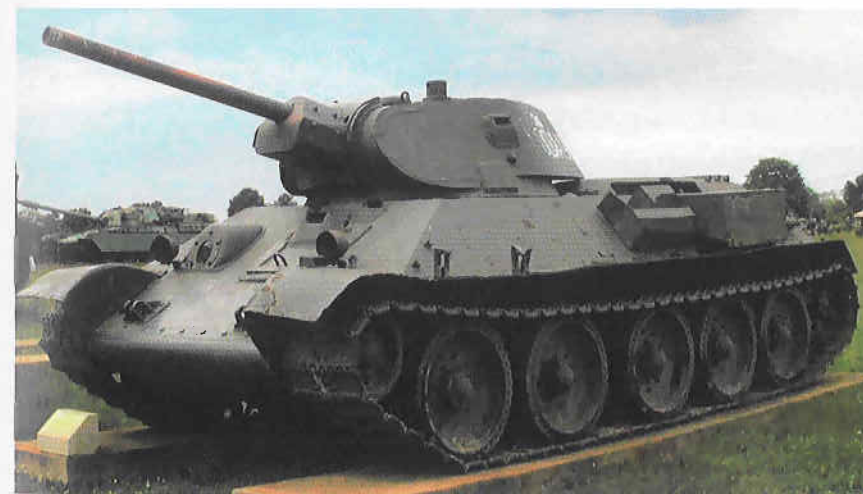
Soviet T-34/76 Model 1941 medium tank with welded turret and rubber-ribbed road wheels. This tank was a great shock to the Germans in 1941 and prompted the development of the Panther. [Author's collection]

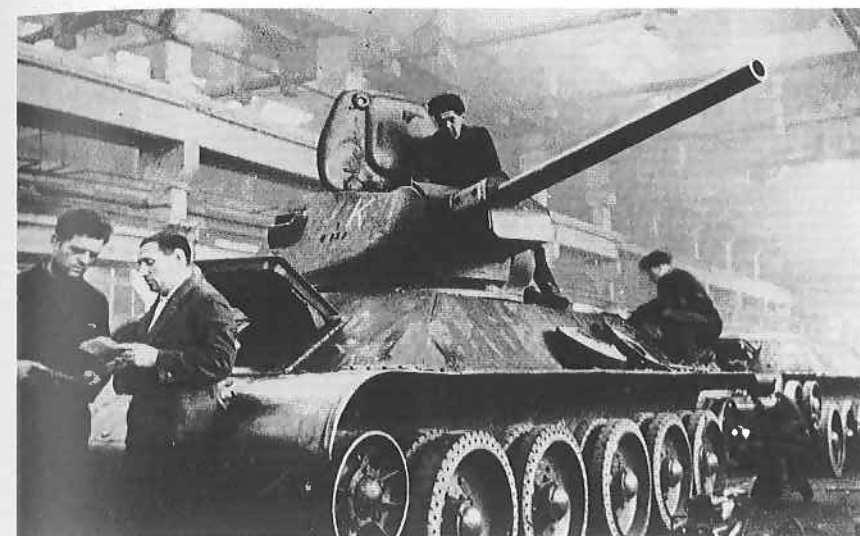
Building a T-34/76 in the Urals. A T-34/76 in 1943 cost 135,000 rubles [\$25,470] and required about 3,000 man-hours to complete. A Panther cost about 129,000 Reichsmarks [\$51,600] and 55,000 man-hours to complete. (Tank Museum, Bovington)

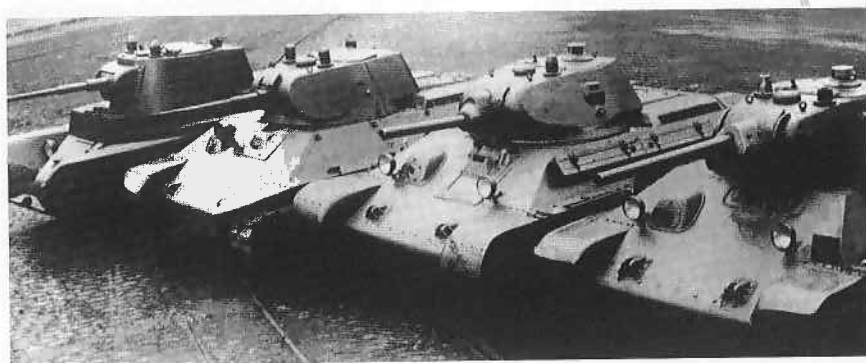
The evolution of the Soviet medium tank: from left-to-right the A-8, the A-20, the T-34 Model 1940, and the T-34 M1941. Between 1938 and 1940, Koshkin doubled the weight of his tank design, increased the gun from 45mm to 76mm and increased armored protection from 22mm to 52mm.

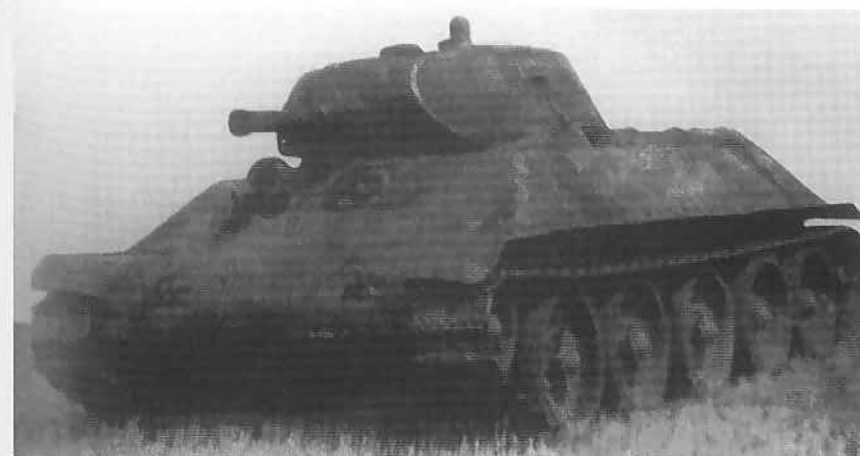
A prototype T-32 medium tank, armed with the L-11 76.2mm gun. Koshkin built this prototype in 1939 on his own initiative and it led to the improved T-34 design. (Kharkov Morozov Machine Building Design Bureau KMDB)

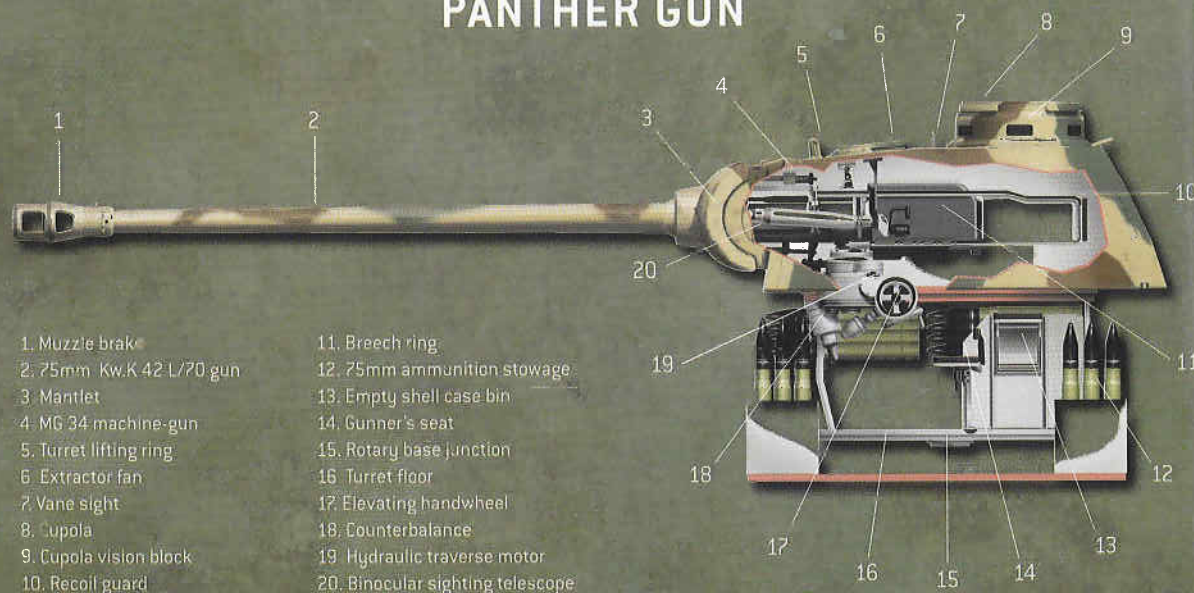
PANTHER GUN

1. Muzzle brake
2. 75mm Kw.K 42 L/70 gun
3. Mantlet
4. MG 34 machine-gun
5. Turret lifting ring
6. Extractor fan
7. Vane sight
8. Cupola
9. Cupola vision block
10. Recoil-guard
11. Breech ring
12. 75mm ammunition stowage
13. Empty shell case bin
14. Gunner's seat
15. Rotary base junction
16. Turret floor
17. Elevating handwheel
18. Counterbalance
19. Hydraulic traverse motor
20. Binocular sighting telescope

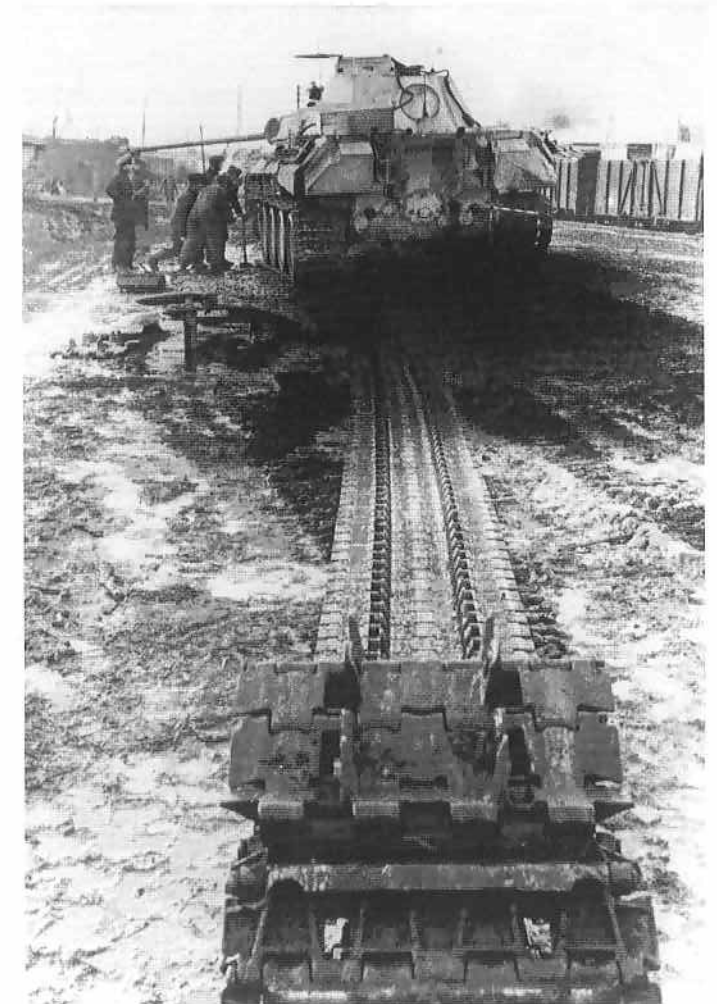
A Panther Ausf. D crew replacing two damaged track blocks on Panther "134" in the fall of 1943. This tank has been towed back to a railhead, apparently after receiving mine damage. Note opened access panels on hull rear for adjusting track tension. [Nik Cornish WH839]

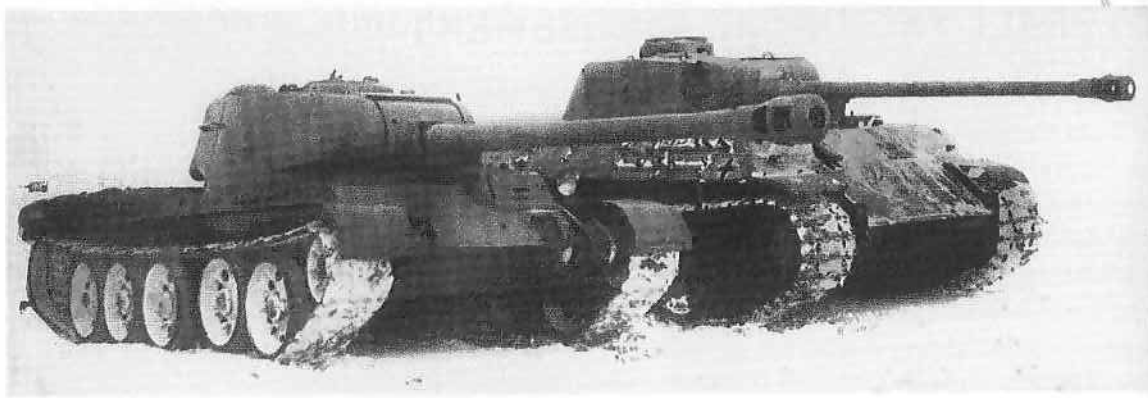
The replacement for the T-34 was the T-44, initially armed with a 122mm gun for evaluation trials with a captured Panther Ausf. D. Limited production began in August 1944 and the service version was armed with an 85 mm gun. (Kharkov Morozov Machine Building Design Bureau KMDM)

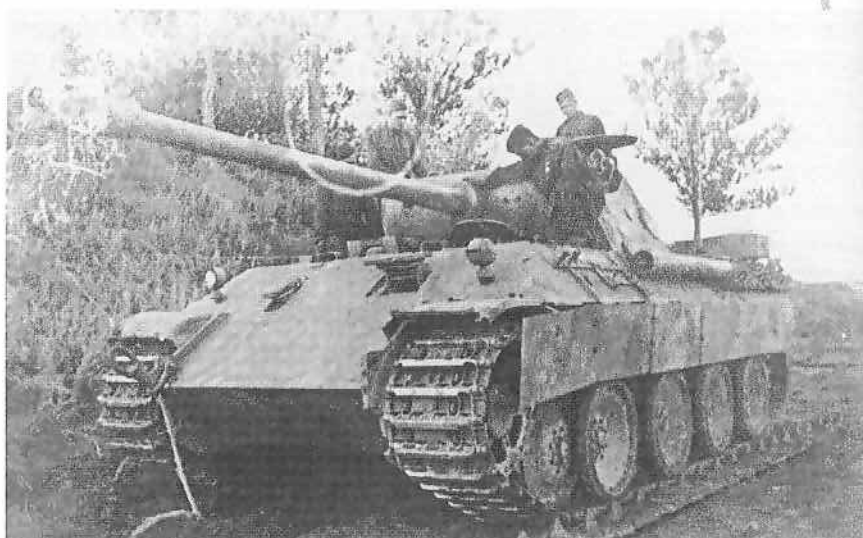
Panther 824 from the 52nd Panzer Battalion, knocked out during *Zitadelle* and captured on July 19, 1943. The nearly intact Panther was sent back to Chelyabinsk for technical evaluation. [Tank Museum, Bovington]

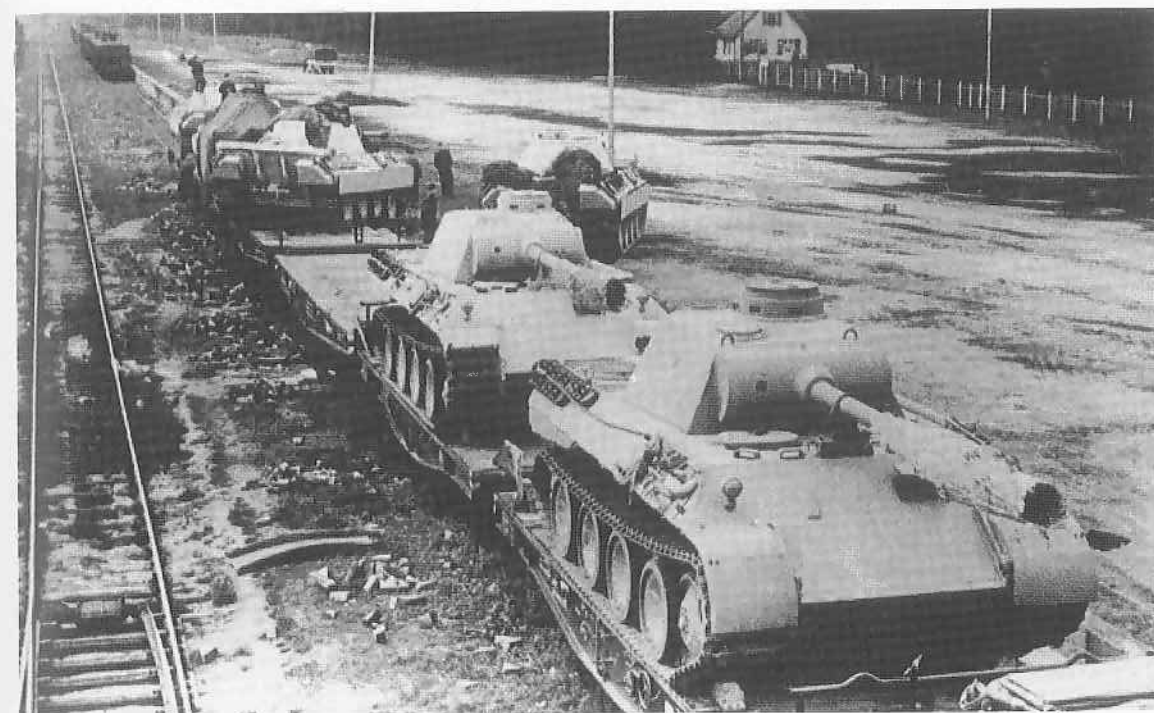
Panther Ausf. D of the 39th Panzer Regiment rail-loaded at Grafenwöhr on June 24-28, 1943 and headed east to participate in Operation *Zitadelle*. It took six days for the Panthers to reach their unloading point at Borisovka. (Robert L. Hunt Library)

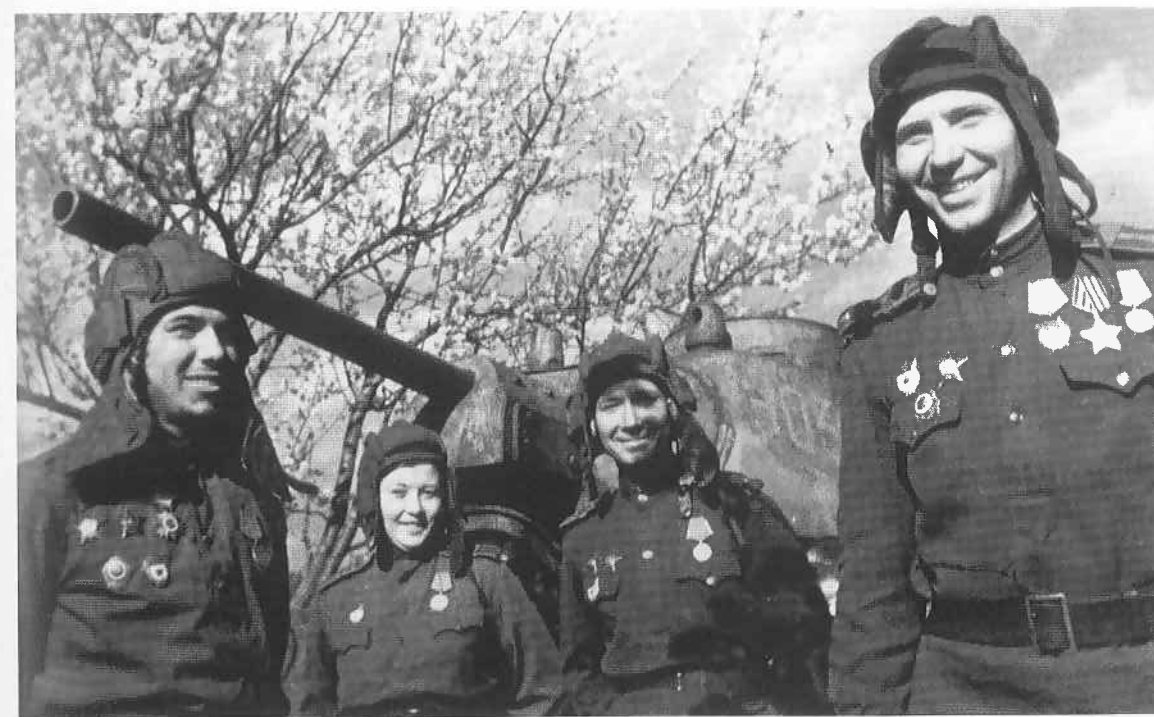
A decorated T-34 crew. Note the commander's cupola on the T-34/76 Model 1943 and the female crew member. By the middle of 1943 women tank drivers were beginning to appear in some Guards units, but they were relatively few in number. [Courtesy of the Central Museum of the Armed Forces Moscow]

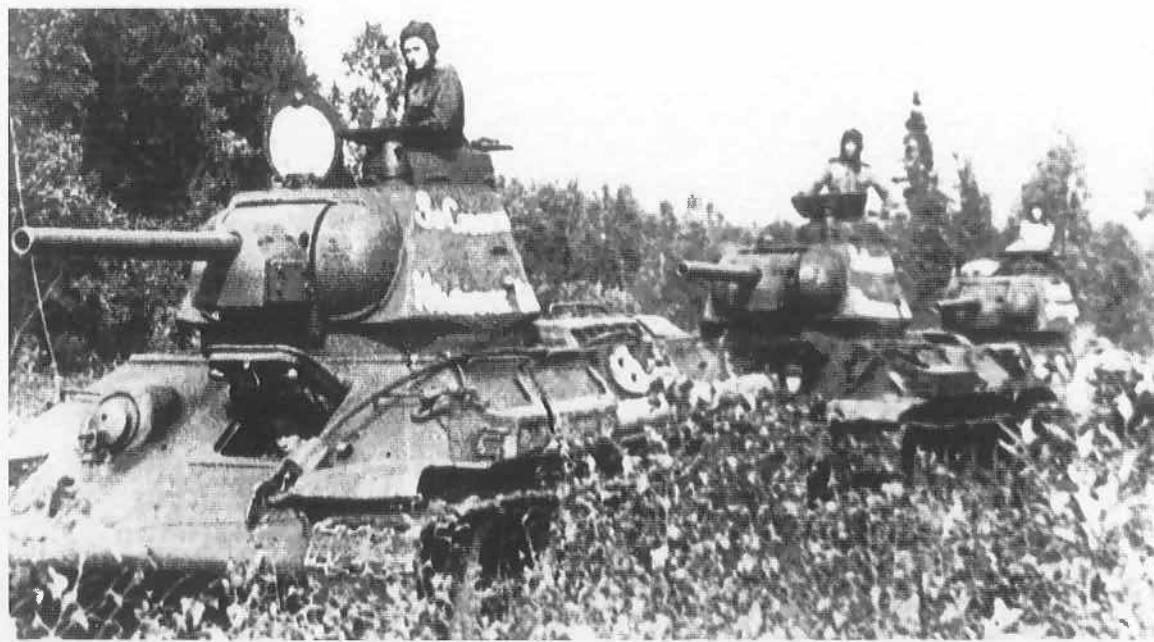
A platoon of late-model T-34/76 Model 1943 with commander’s cupola. The introduction of this cupola corrected a design flaw and finally gave tank commanders the ability to fully view the battlefield. [Courtesy of the Central Museum of the Armed Forces Moscow]

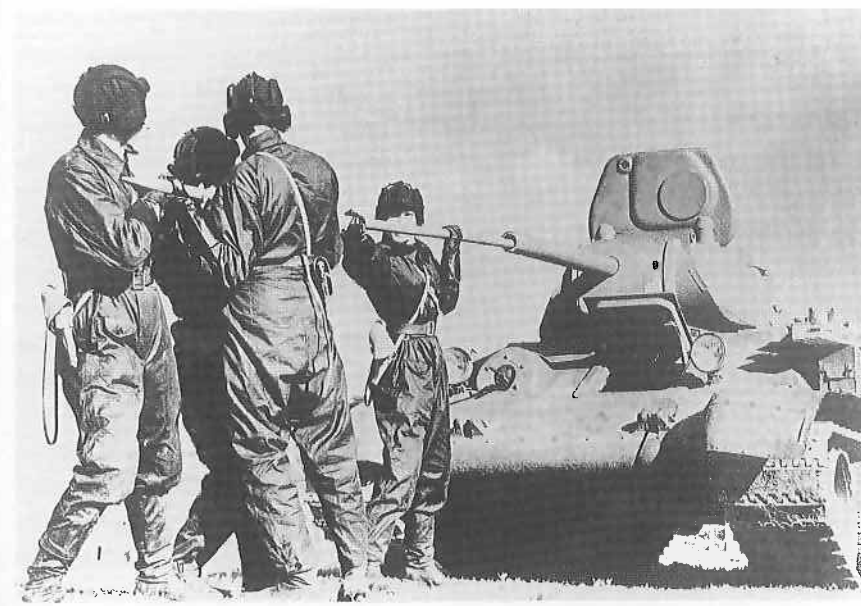
A T-34 crew “punches the gun tube” in order to clean the F-34’s gun barrel of carbon residue after firing a significant number of rounds. [Tank Museum, Bovington]

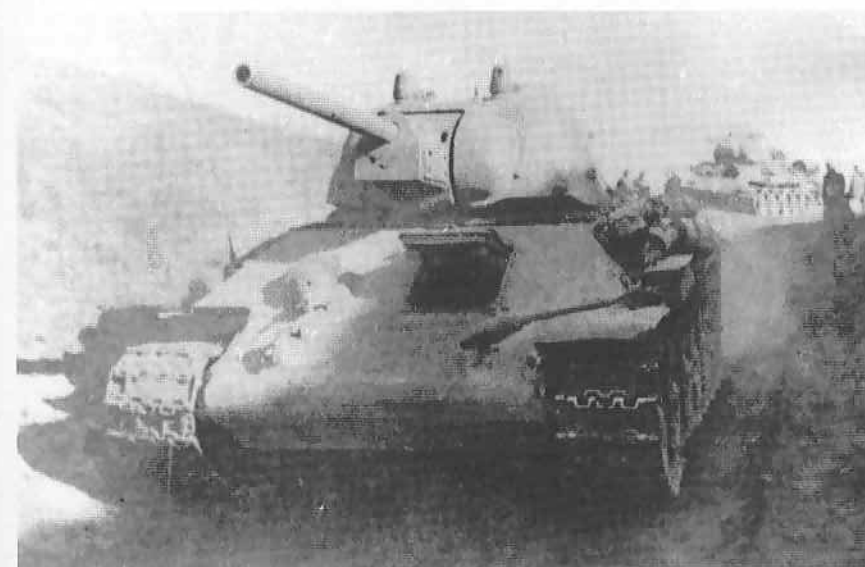
The large driver's hatch on the T-34 made ammunition loading easier and offered better chances for escape in the event of the tank being hit. (Courtesy of the Central Museum of the Armed Forces Moscow)

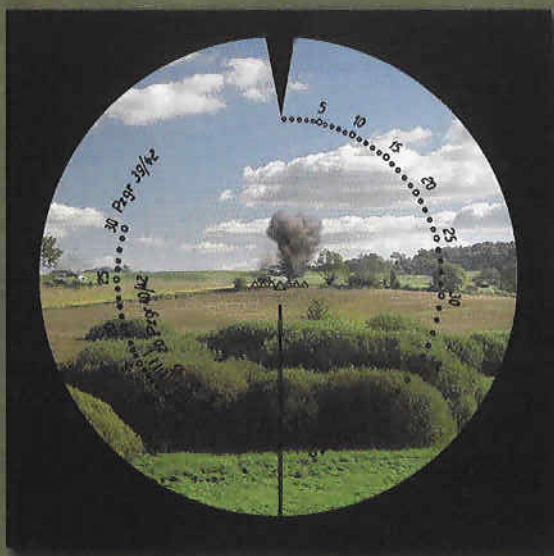
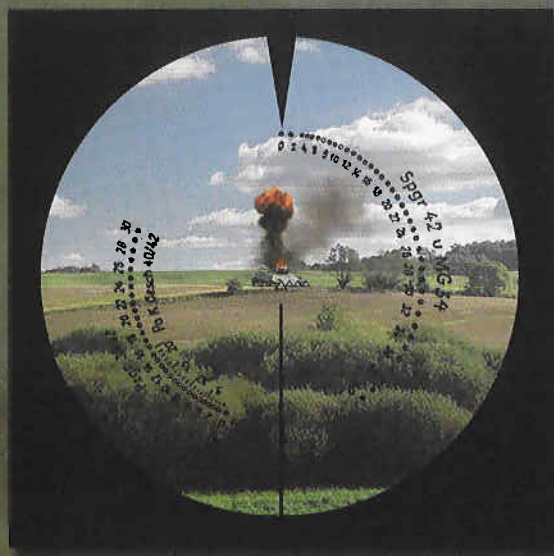
PANTHER GUNNER'S VIEW, AUGUST 1943

Commander: Panzergranate! Laden und sichern! Load Armor Piercing!

Loader: Panzergranate geladen! Armor Piercing loaded

Commander: 3 Uhr! Panzergranate – 800 – Panzer! 3 o'clock! Armor piercing – 800m – tank!

Gunner: Achtung! On the way!

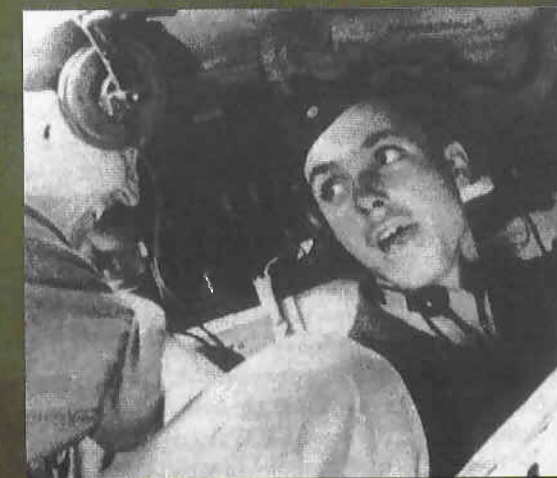
German tank gunner's position, with commander right behind him. An illustration of the cramped quarters within the tank.

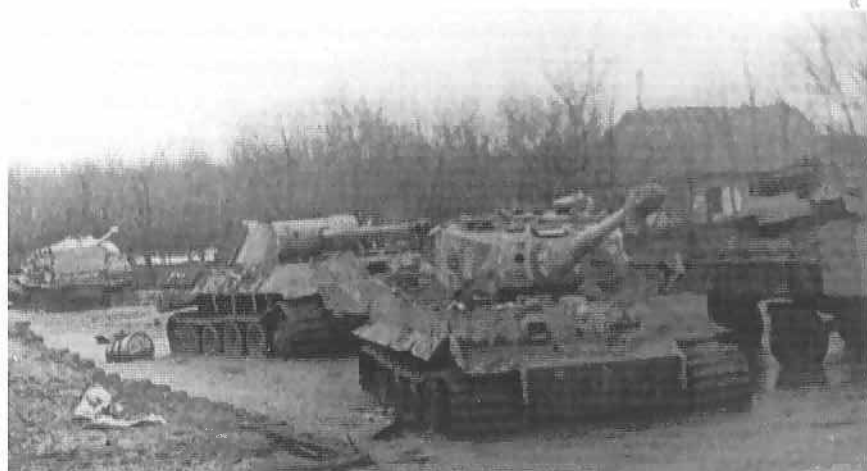
Panzer graveyard at Tomarovka, with two Panther Ausf. D and a Tiger. The retreating Germans destroyed about 70 immobilized Panthers on August 5, 1943. Note the Panther to the left has its turret roof blown off by the force of the internal explosion. (Courtesy of the Central Museum of the Armed Forces Moscow)

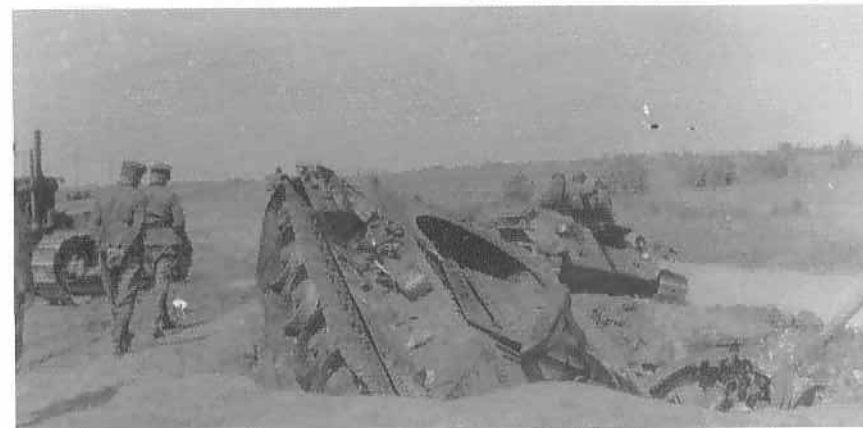
Two destroyed T-34 Model 1941 tanks. It was not uncommon for the T-34's own ammunition to "cook off" after an internal fire and blow the turret off. [Nik Cornish WH617]

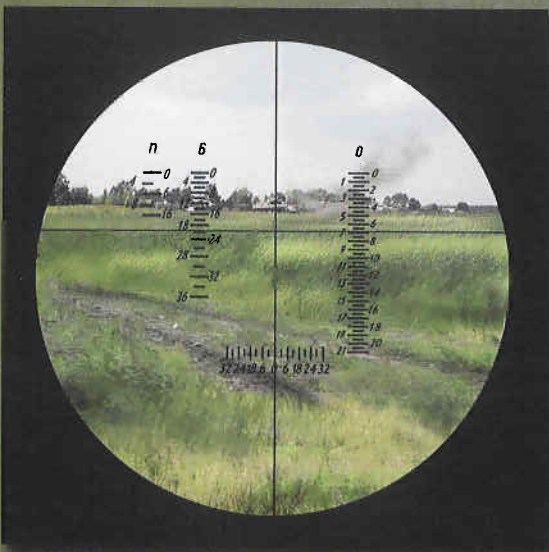
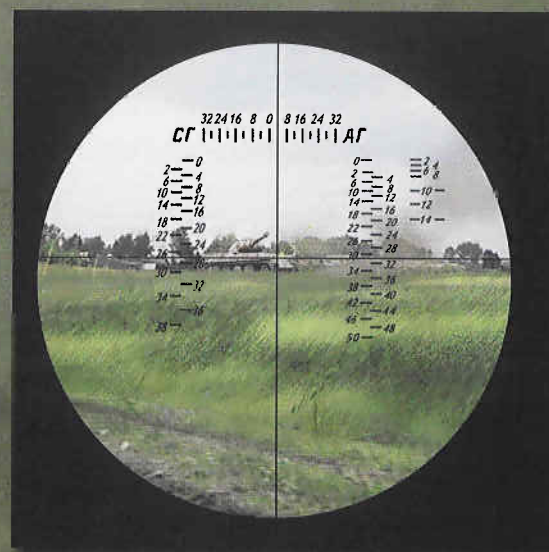
View through the PT-47 sight. Unlike the Panther, the T-34 did not have a gunner so there was no one to give commands to, the commander firing the gun himself.

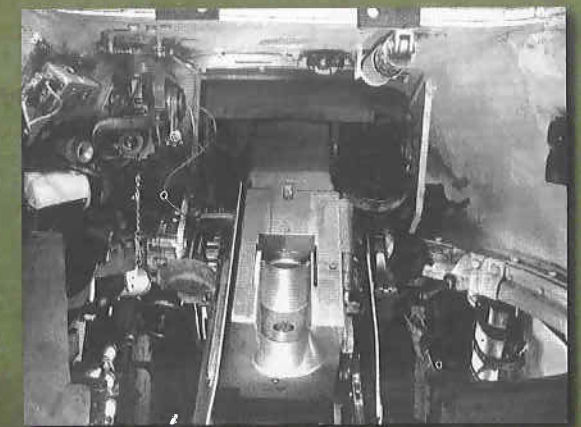
T-34/76 turret interior. The eyepiece for the PT-47 rotating periscope is toward upper left of this photo. The padded eyepiece for the TMFD sight is just to the left of the main breech gun, and next to the turret elevation handle.
